# DOE Type A Accident Investigation

Drilling Rig Operator Injury at  
Fermi National Accelerator Laboratory  
June 21, 2001

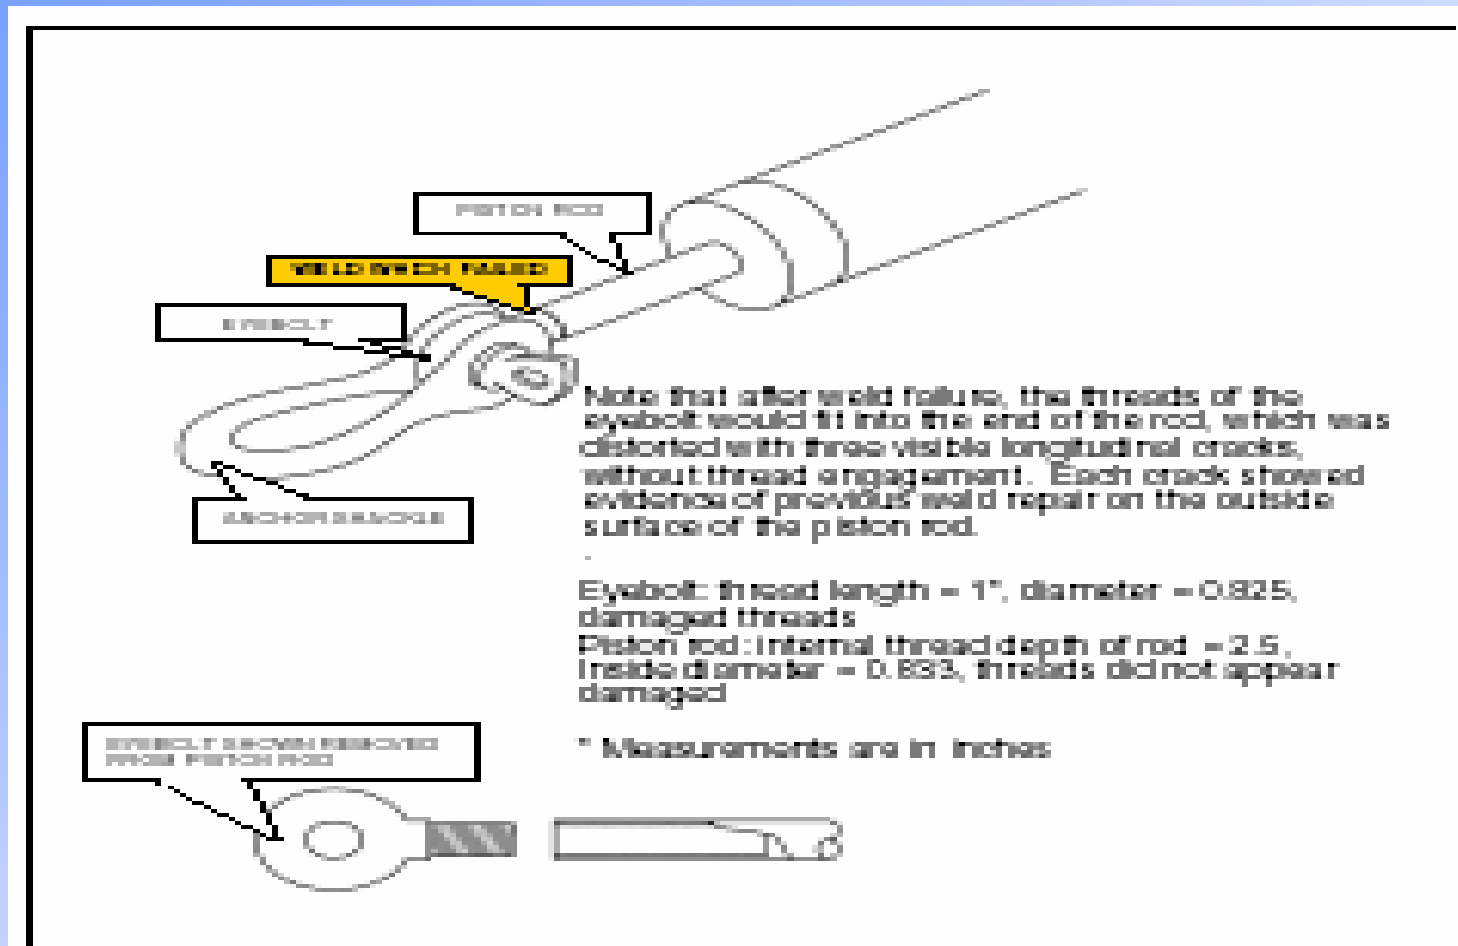
**Figure 2-1. Piston Rod End Fixture**

# Piston Rod/Eye Bolt Assembly

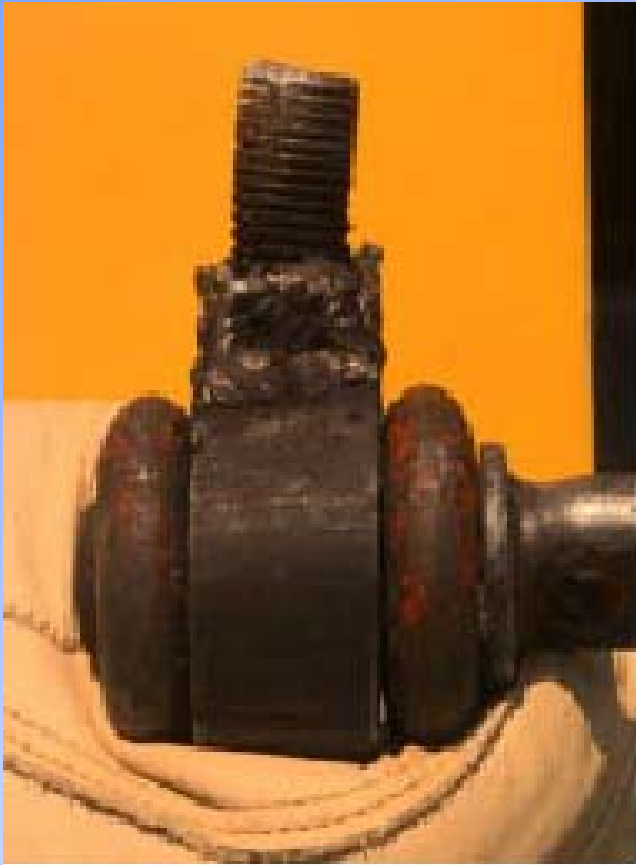
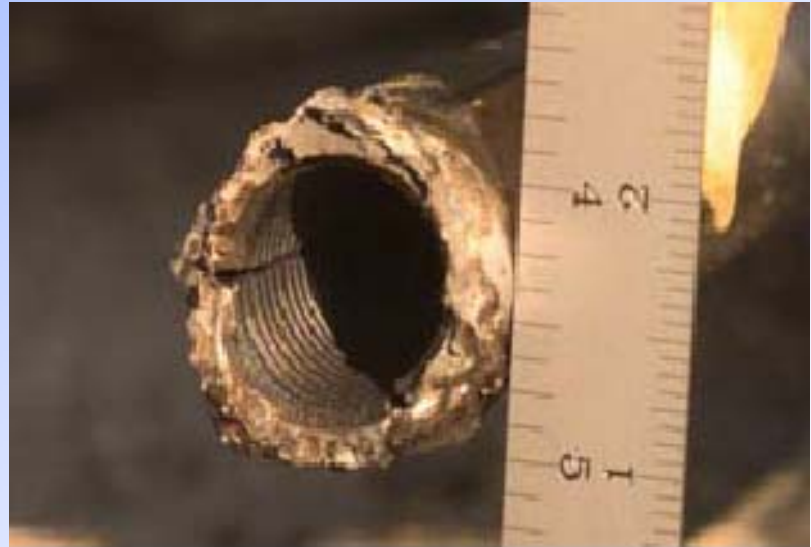
# Failed Eyebolt

- Direct Cause – Equipment Failure (weld)
- Root Cause – Mgmt failure to implement HA process (task specific hazards)
